MANAGING THE FLOOD RISK IN COFFS HARBOUR IN THE AFTERMATH OF THE 1996 FLOOD

*John Maddocks, Bewsher Consulting Pty Ltd
John Rowe, Coffs Harbour City Council*

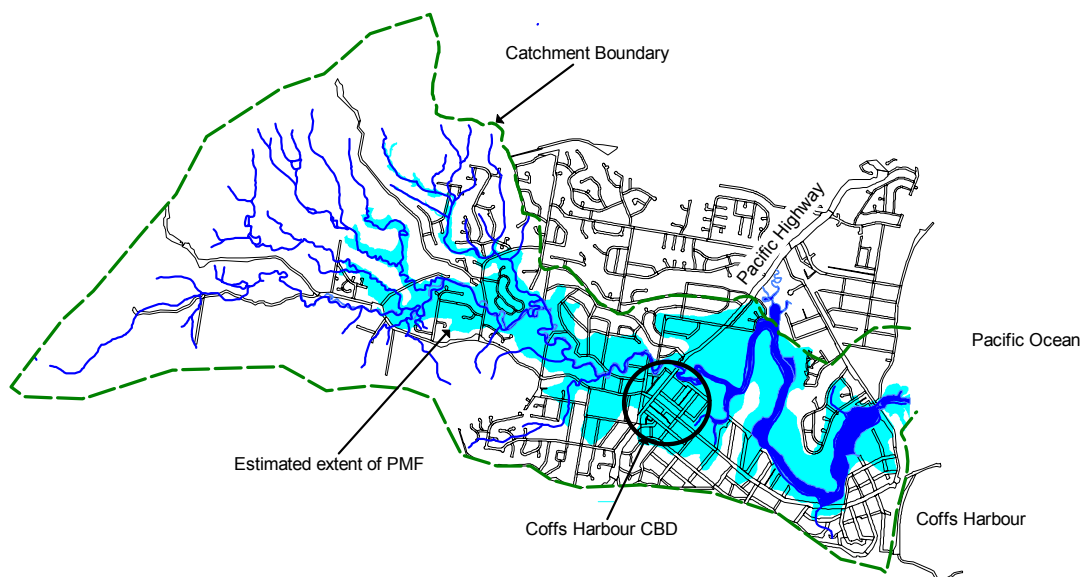
Figure 1 – The Coffs Creek Catchment

Coffs Creek is a small coastal stream typical of those that drain from the coastal range. The creek, shown on Figure 1, is roughly rectangular in shape and has a catchment area of about 25km².

The catchment divide is located about 9km from the coast, with a maximum height of around 490m. The upper slopes of the catchment are very steep and largely occupied by banana plantations.

About 60% of the catchment is either urbanized or zoned urban. Most development is located towards the middle to lower part of the catchment. The Coffs Harbour CBD is located in the lower catchment, on either side of the Pacific Highway. The Creek is tidal downstream of the highway, and becomes a broad estuary as it meanders towards the ocean. This lower estuary is characterised by relatively dense mangroves and large shoals of marine sand.

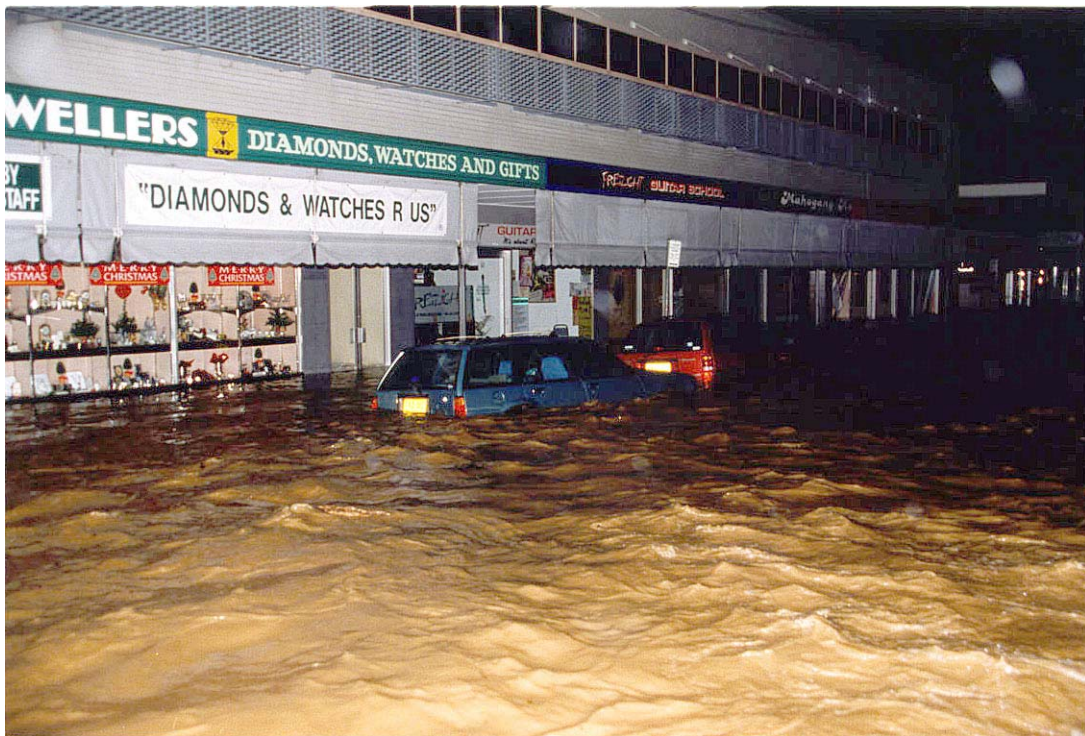
Photo 1 – Much of the commercial area of Coffs Harbour was affected by the 1996 flood

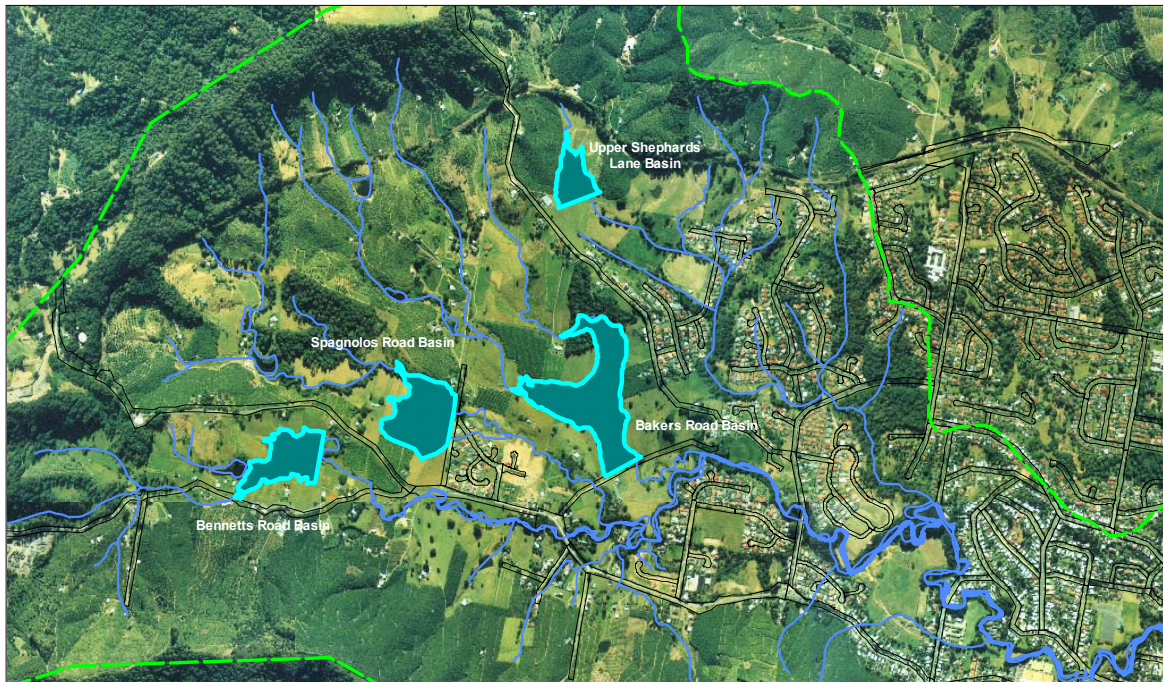
Figure 2 – Proposed Basin Strategy in the Upper Catchment

A strategy was developed which included four basins in the upper catchment, ranging in storage capacity from 100,000m³ to 270,000m³. These are relatively large basins, which could reduce downstream flood levels in a 100 year flood by as much as 0.5m if all four were built. The total cost of the four basins is estimated to be of the order of \$8.5M (includes land acquisition).
